Testing of a Stitched Composite Large-Scale Multi-Bay Pressure Box

Dawn Jegley,¹ Marshall Rouse,² Adam Przekop,¹ Andrew Lovejoy¹
NASA Langley Research Center, Hampton, VA 23681

NASA has created the Environmentally Responsible Aviation (ERA) Project to develop technologies to reduce aviation's impact on the environment. A critical aspect of this pursuit is the development of a lighter, more robust airframe to enable the introduction of unconventional aircraft configurations. NASA and The Boeing Company have worked together to develop a structural concept that is lightweight and an advancement beyond state-of-the-art composite structures. The Pultruded Rod Stitched Efficient Unitized Structure (PRSEUS) is an integrally stiffened panel design where elements are stitched together. The PRSEUS concept is designed to maintain residual load carrying capabilities under a variety of damage scenarios. A series of building block tests were evaluated to explore the fundamental assumptions related to the capability and advantages of PRSEUS panels. The final step in the building block series is an 80%-scale pressure box representing a portion of the center section of a Hybrid Wing Body (HWB) tr

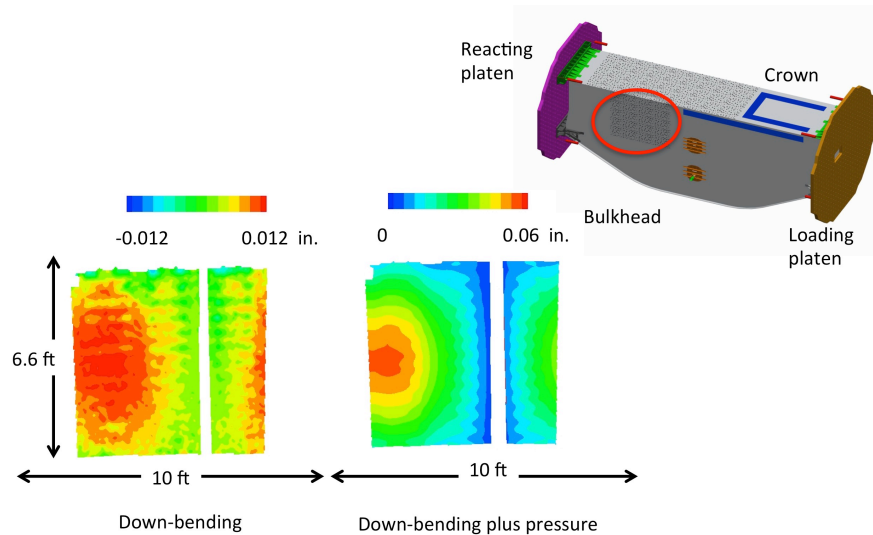
load case. These buckles occur near the bulkhead-to-crown attachments and are caused by the shear loading in the bulkheads induced by the bending of the test article. While buckles in the crown and keel acquire an in-out pattern early in the test and retain that pattern, the buckle mode shape in the bulkheads changes with as loading is increased. The largest out-of-plane deformation is in the upper bulkhead in the pressure-only load case since that case applies the largest pressure load and the bulkhead has the largest distances between connections to other panels.

Deformation patterns for the bulkhead at the additional load levels of 60% and 90% DUL are shown in Fig. 21. This change in displacement pattern includes changes in the number of half-waves in the buckled region. Regardless of the cause or magnitude, these buckles occurred in DLL and DUL tests and did not appear to cause damage to the test article and did not compromise the ability of the test article to support DUL.

Figure 16. Bulkhead full-field out-of-plane displacements for the down-bending and down-bending plus pressure load cases.

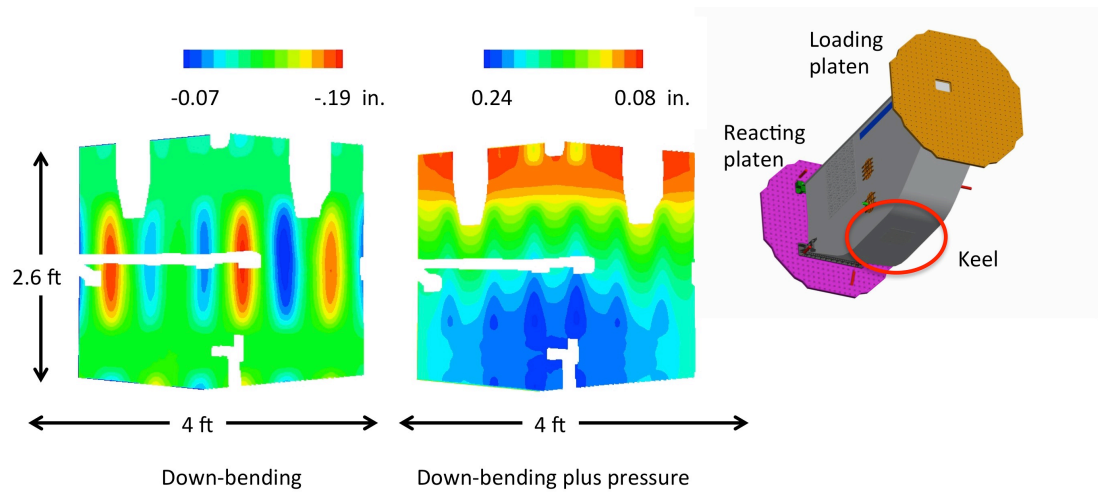
Figure 17. Center keel full-field out-of-plane displacements for the down-bending and down-bending plus pressure load cases.

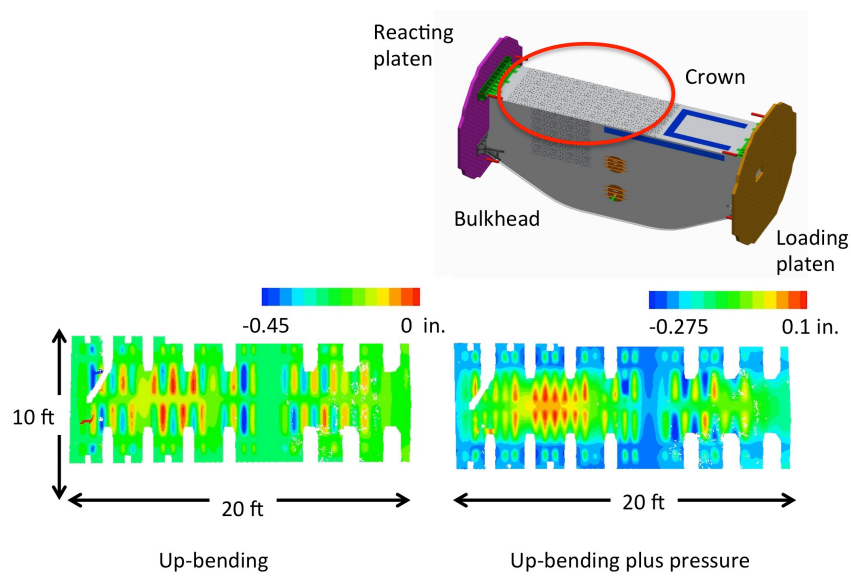
Figure 18. Crown full-field out-of-plane displacements for the up-bending and up-bending plus pressure load cases.

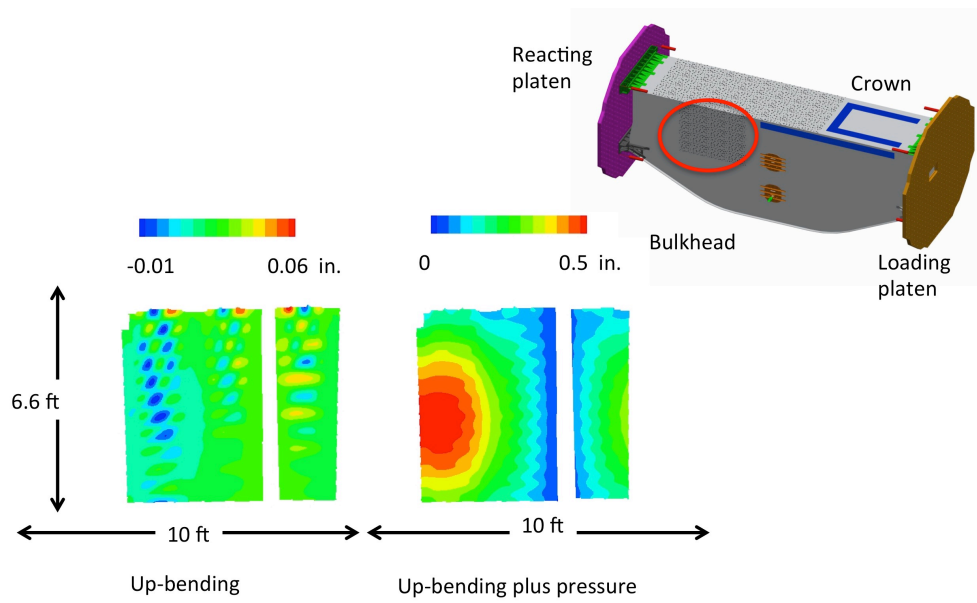
Figure 19. Bulkhead full-field out-of-plane displacements for the up-bending and up-bending plus pressure load cases.

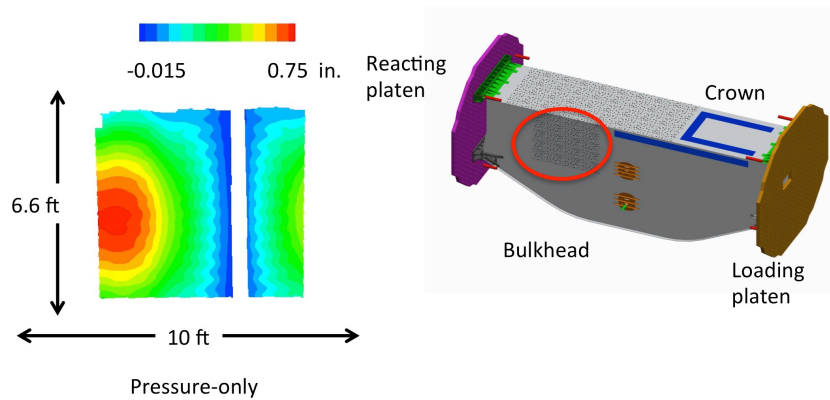
Figure 20. Bulkhead full-field out-of-plane displacements for the pressure-only load case.

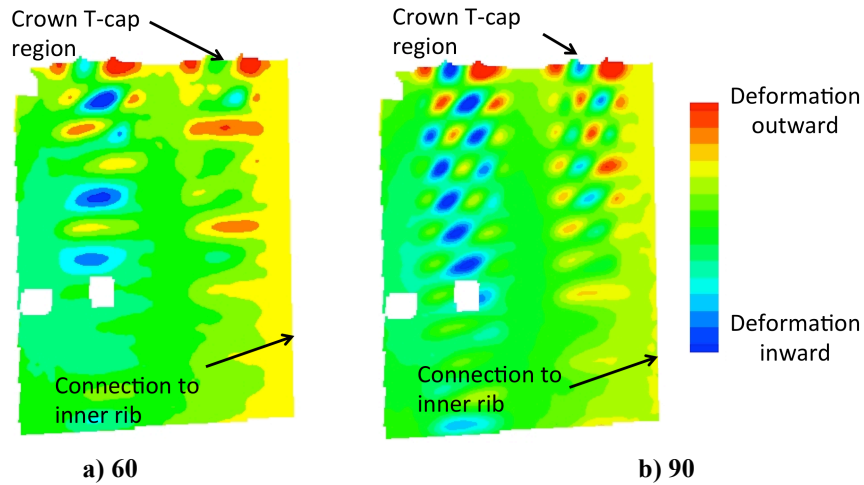
Figure 21. Bulkhead out-of-plane deformation pattern changes as the mechanical loading increases in up-bending load case (percentage of DUL).

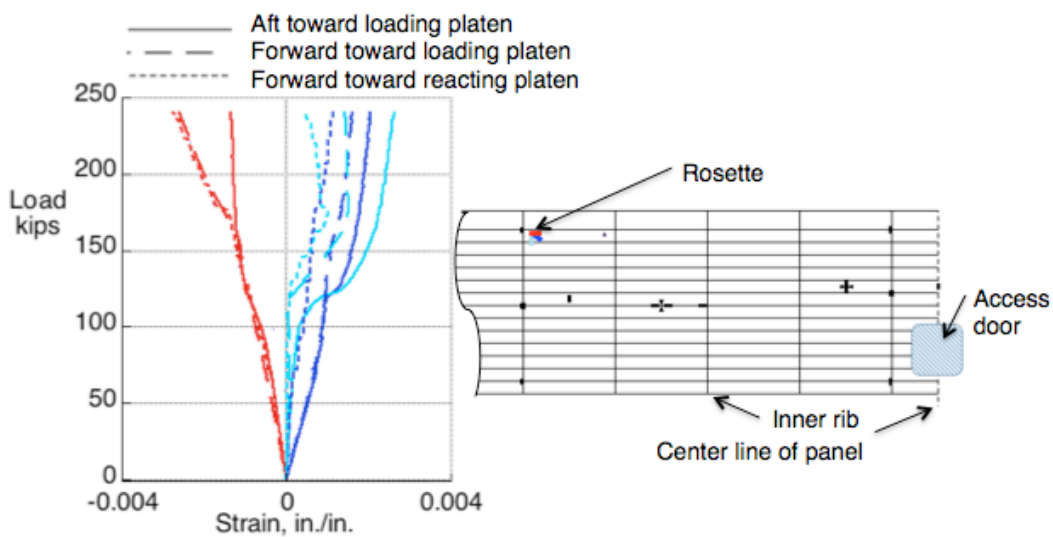
Strain gauges were placed on the skin of upper bulkhead panel on the unstiffened (exterior) side near the connection to the crown panel in three quadrants of the test article (the fourth similar location was in the region where full-field data were acquired). Results for these strain gauges are shown in Fig. 25 and 26. These strain gauges were rosettes measuring strain parallel to the frame, perpendicular to the frame, and at a 45-degree angle to the frame. The colors of the curves on the plot correspond to the strain gauge locations shown in the inset image of the crown panel and the solid curves represent the locations toward the aft side of the test article. The long and short dashed curves represent the locations toward the forward side of the test article closer to the loading platen and the reacting platen, respectively. These measurements show that the largest magnitude of these strains is parallel to the frame and does not exceed 0.004 in./in. The abrupt change in slope in these strains as loading increased and the changes in VIC patterns indicates that the skin at these locations buckled, and that different bays changed mode shape at different load levels.

Figure 25. Strain on the exterior upper bulkhead skin from outboard strain rosettes.

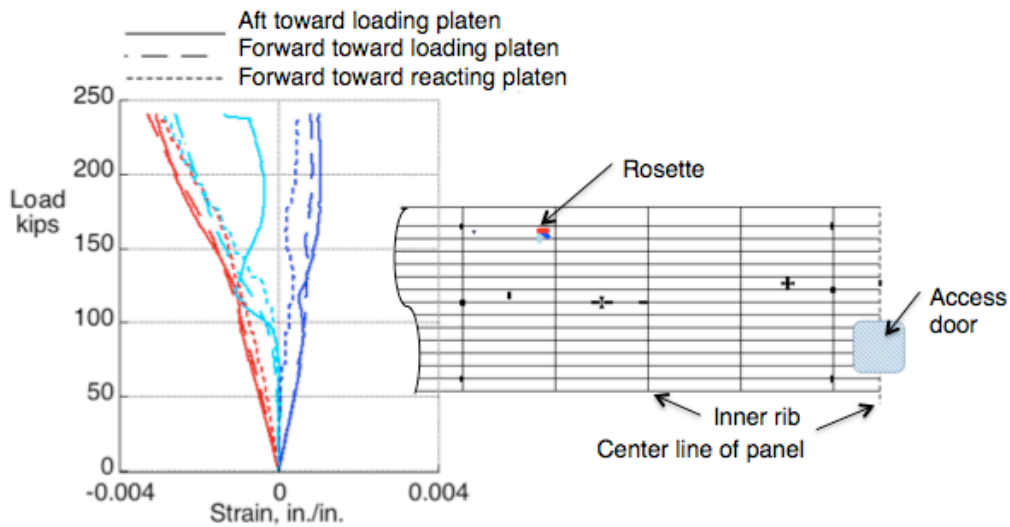
Figure 26. Strain on the exterior upper bulkhead skin from inboard strain rosettes.

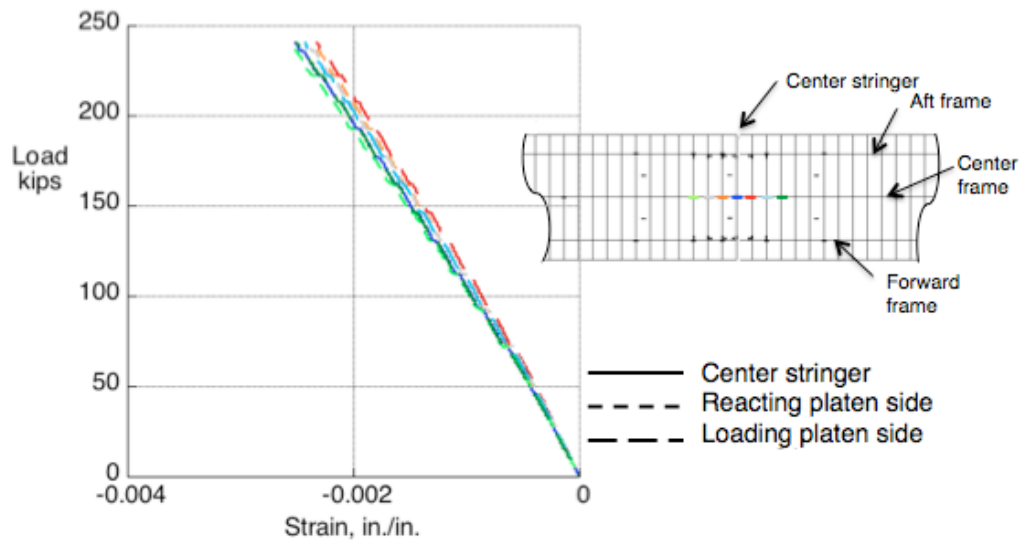
In previous studies considering PRSEUS panels loaded in the frame direction, strain concentrations in the frame web near the keyhole contributed to panel failure.⁷ To address that failure mode, additional stack material was placed in a cavity in the frame foam to reduce this concentration at the more highly loaded keyholes to prevent premature failure at this local feature.²¹ To evaluate this design modification, strain gauges were placed on the center frame web approximately 0.3 inches away from the keyhole and parallel to the frame at critical frame-stringer intersections. The highest loading for the crown and keel frames was in the up-bending condition, placing the keyhole region in compression in the crown and tension in the keel. Results for seven critical keyholes for the crown center frame are shown in Fig. 27. Results for seven critical keyholes in the center keel in the center, forward, and aft frames are shown in Fig. 28a, 28b, and 28c, respectively. The keyhole strains did not exceed the design values in tension or compression. No damage was observed at these locations after the completion of all DUL tests.

Figure 27. Strain in the crown center frame in a web above keyholes.

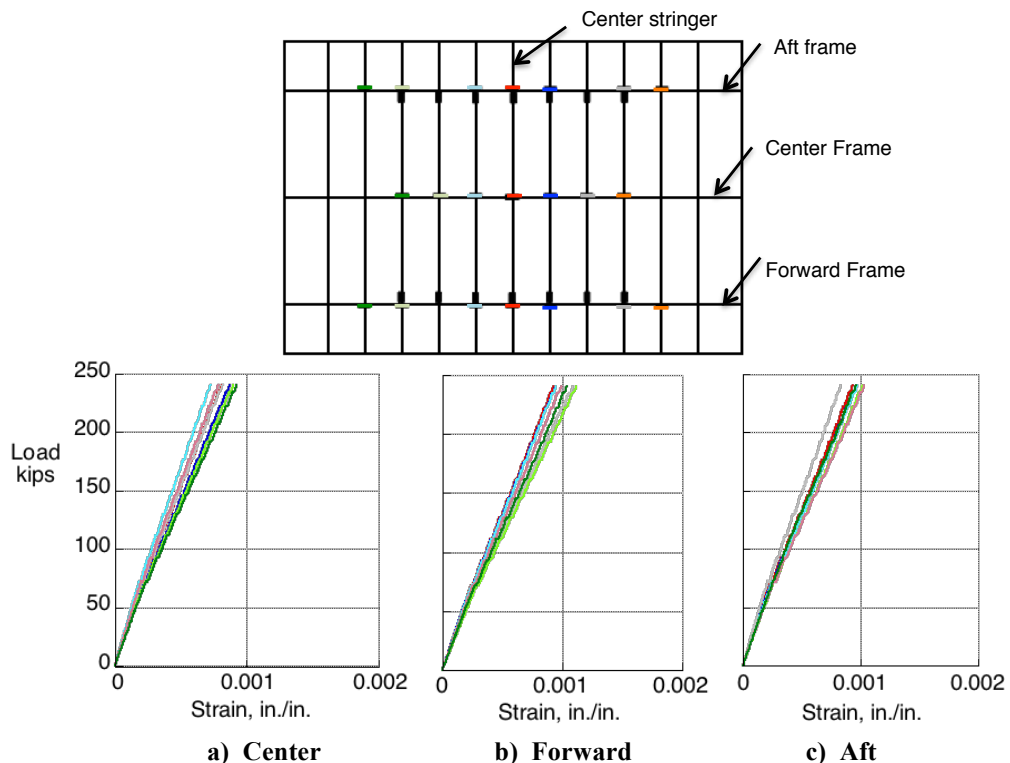
Figure 28. Strain in the center keel frame webs above keyholes.

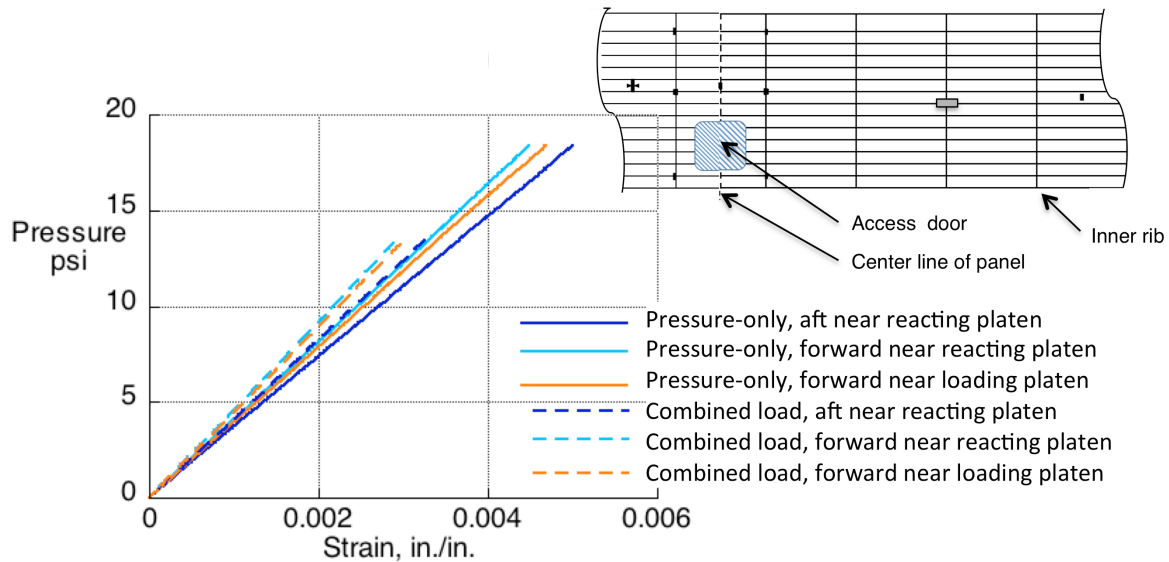
In previous studies considering PRSEUS panels under pressure, strain concentrations in the stringer near the keyhole approached the design value.¹¹ The largest strains in the stringers under the pressure loading would be near the center of the largest unsupported region. For the MBB, that location is in the upper bulkhead panels approximately half way between the floor and the crown and half way between the inner and outer ribs. Strain gauges were placed on the top of three stringers in the upper bulkhead panels, parallel to the rod and near the keyhole. The results for these gauges are shown in Fig. 29 for the pressure-only and up-bending plus pressure load cases. The gauge location is indicated by the gray box in the inset image, where only half of one bulkhead panel is shown since the other locations are symmetric in the other quadrants of the test article. The fourth strain gauge at these symmetric locations is not shown since that gauge stopped functioning early in the test sequence. The strains at the top of the stringer are linear throughout loading and do not exceed the design strain values. The strains for the pressure-only load case are slightly greater than the strains for the combined load case, indicating that the addition of the bending load slightly reduces the strain in the bulkhead stringers by preventing the bulkhead from bowing outward as much as when pressure is present.

Figure 29. Strain in the top of the stringers of the upper bulkheads for up-bending plus pressure and pressure-only load cases.

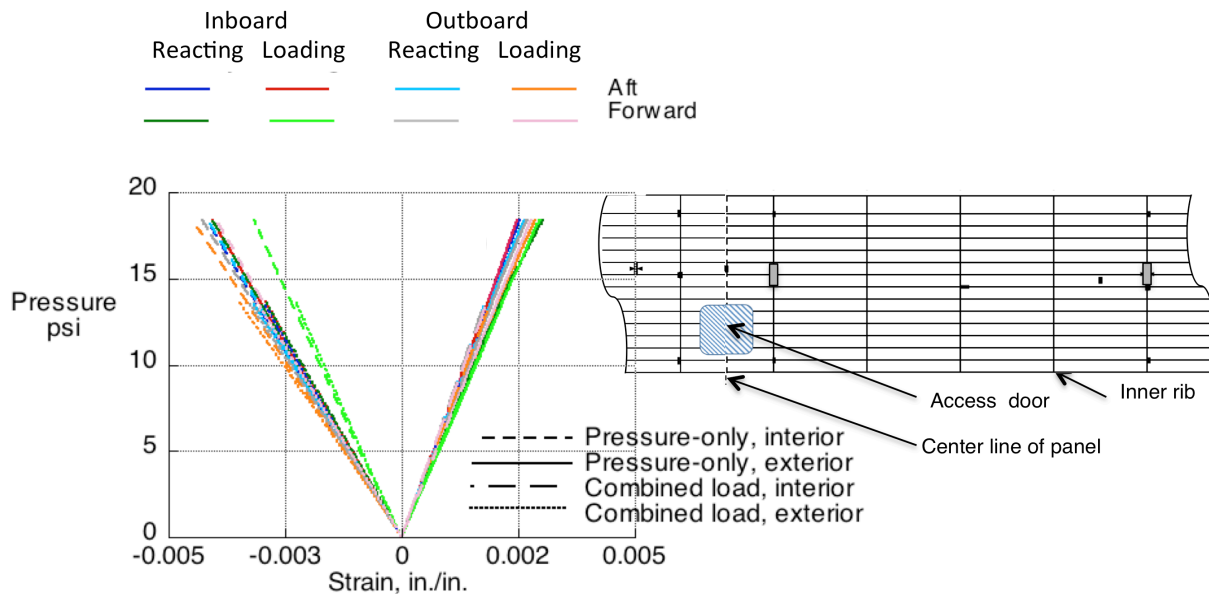
Similarly, strains in the frames in the upper bulkhead panel can be significant when the panel bows outward during pressure loading. Strains at the top of the frames and on the external surface at the frame location in the upper bulkhead panels are shown in Fig. 30 at the locations indicated by the gray boxes in the inset sketch of an upper bulkhead panel. The results shown are for the pressure-only and up-bending plus pressure load cases. Strains on the unstiffened (exterior) surface are represented by solid curves and strains on the frames are represented by dashed curves. These strains do not exceed the design strain values. The strains for the pressure-only and combined load cases are indistinguishable, so the bending load does not contribute to the frame strain.

Figure 30. Strain in the top of the frames of the upper bulkhead for up-bending plus pressure and pressure-only load cases.

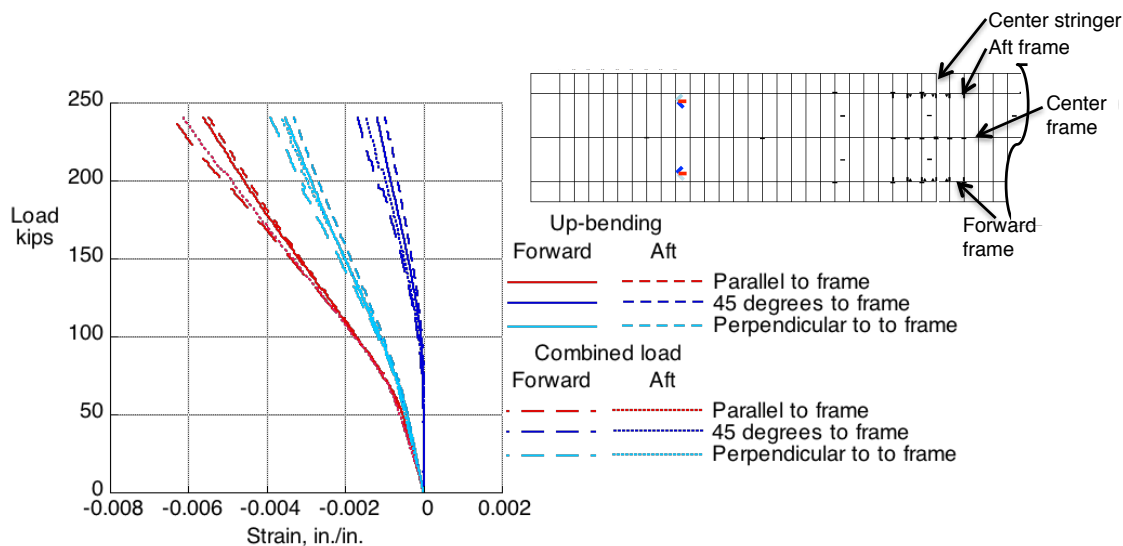
Figure 31. Strain in the strain rosettes on the interior of the crown in the up-bending plus pressure and pressure-only load cases.

Pre-test analysis of the MBB indicated that there would be high strains in the crown panel skin on the stiffened (interior) side near the outer frame flanges and half-way between the stringers in the up-bending and up-bending plus pressure load cases.²² These strains are shown in Fig. 31. These strain gauges were rosettes measuring strain parallel to the frame, perpendicular to the frame and at a 45-degree angle to the frame. The solid and short dashed curves represent the strains in the up-bending load case and the long dashed curves and the dotted curves represent the strains in the up-bending plus pressure load case. The strains in the combined-load case are slightly greater than the strains in the up-bending load case. Therefore, it is clear that the mechanical load influences these strains more than the pressure loading. These measurements show that the largest magnitude of these strains is parallel to the frame and does not exceed -0.006 in./in. This strain exceeds the design strain value of -0.0048 in./in. for damaged structure, but not the unnotched (pristine) value of -0.008 in./in.

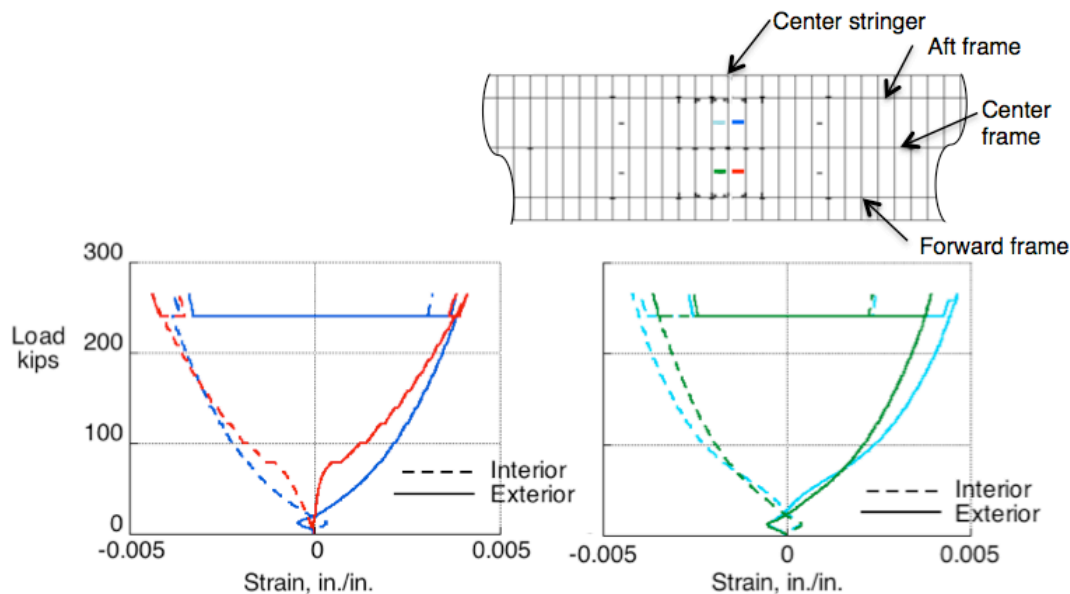
Figure 32. Strain in the crown skin in the load case to a load greater than DUL.

The final BVID test subjected the test article to load greater than DUL in the up-bending and up-bending plus pressure load cases. In this case, the behavior of the crown and bulkhead are of interest. A behavior to consider is the strains in the crown skin at mid-bay locations, as shown in Fig. 32, using the same color scheme and curve type as described for Fig. 23. These results show that there is a change in buckle pattern early in the loading sequence, evidenced by the reversal in direction of the mid-bay back-to-back strain gauge results for the four mid-bay strain gauges closest to the center of the panel. After this reversal, strains increase in magnitude smoothly until the maximum mechanical load is reached, then decrease in magnitude as mechanical load is removed. Then, the strains change direction as pressure is removed. i.e., the tension surface goes into compression and the compression surface goes into tension. Finally, the strains increase again in magnitude, but at significantly less magnitude as the mechanical load is increased when no pressure is present. In order to clarify the behavior, consider the results using one back-to-back pair. The dark blue dashed and solid curves are an example of interior and exterior mid-bay strains.

Each strain reverses direction at approximately 20 kips. Then, the strain magnitude increases smoothly until the maximum mechanical load is achieved, even though the pressure loading was not increased after 238 kips. At the maximum mechanical load, the strain decreases in magnitude on almost the same path as the strain went up. However, when the pressure load is removed, the strains reverse direction while the mechanical load is held, indicating that the buckle in that bay has changed from outward (the exterior strain is in tension) to inward (the exterior strain is in compression). This change in deformation pattern is evident in the full-field measurements shown in Fig. 33, where the deformation at 110% DUL is shown with internal pressure and without internal pressure. All deformation half-waves are outward when internal pressure is present while, for the most part, the half-waves alternate in direction when pressure is not present.

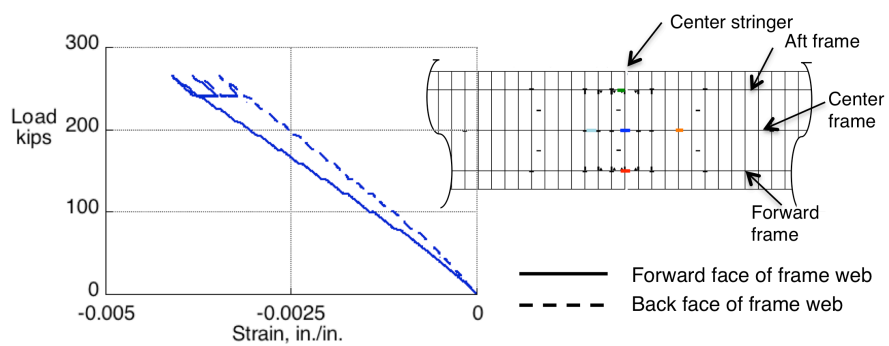
Figure 34. Strain in the crown frame web for the load case to a load greater than DUL.

Finally, the only other high strains are shown in Fig. 34 and 35, where strain in the crown is shown in the center frame web, and at the skin strain rosettes, respectively. The linear nature of the frame web behavior for strains on the front face and the back face indicates that the frame does not buckle. Strains on the webs of the center frame of the crown panel exhibit relatively high strains, as shown in Fig. 34. These strains remain linear throughout each phase of testing and do not indicate any buckling or rolling of the frames.

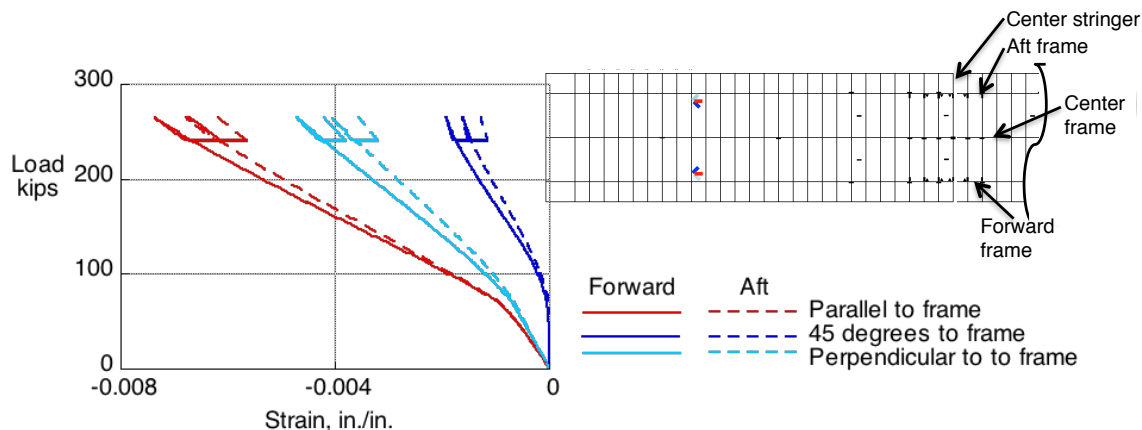
Figure 35. Strain in the crown skin strain rosettes load case to a load greater than DUL.

The mid-bay skin gauges whose results are shown for the up-bending load case are shown in Fig. 35 for the loading greater than DUL. Strains are greater than the design allowable, but no damage is evident. The maximum strain in the rosette is large, but does not show any indication of failures in this area. No visible damage growth was observed at any of the impact sites following the DUL or over-DUL tests. Additionally, ultrasonic scans performed in between loadings found no growth in damage compared to the damage found immediately following the impacts. A visual inspection of the entire box revealed no other damage.

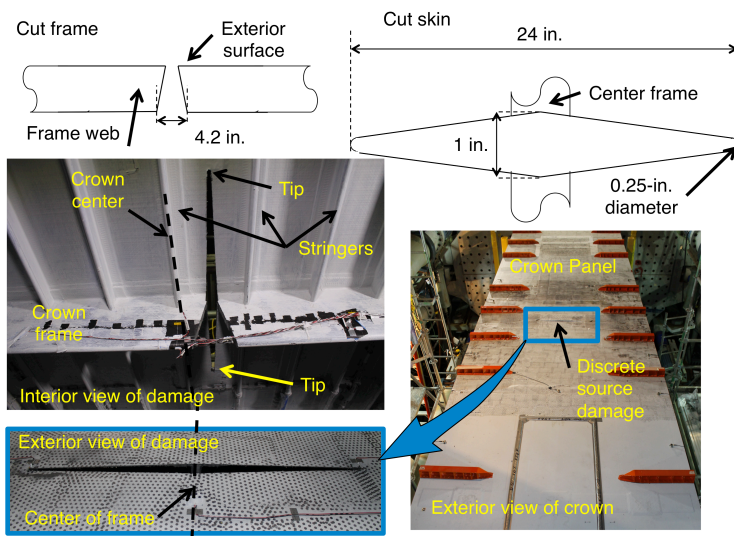
Figure 36. DSD geometry. Sketches not to scale.

Since the test article displayed no damage growth from the impact sites and no damage elsewhere, an additional test was implemented. After the BVID tests were completed, the center frame in the crown panel was severed mid-bay to mid-bay, resulting in a 24-in. long cut. The entire depth of the web, the flanges and adjacent skin of the center frame were severed in a diamond shape, as shown in Fig. 36. A diamond shape, rather than a simple slot, was used because the edges would be pushed together during loading and contact between the cut edges was to be avoided. The ends of the cut were rounded and the cut through the frame height was tapered. Strain gauges were added to the interior skin and flanges in the vicinity of the DSD, the exterior was re-speckled to accommodate a local VIC system, and then the structure was loaded in the up-bending load case to failure. With this level of damage, an aircraft structure would be required to support 70% of DLL, or approximately 47% DUL.

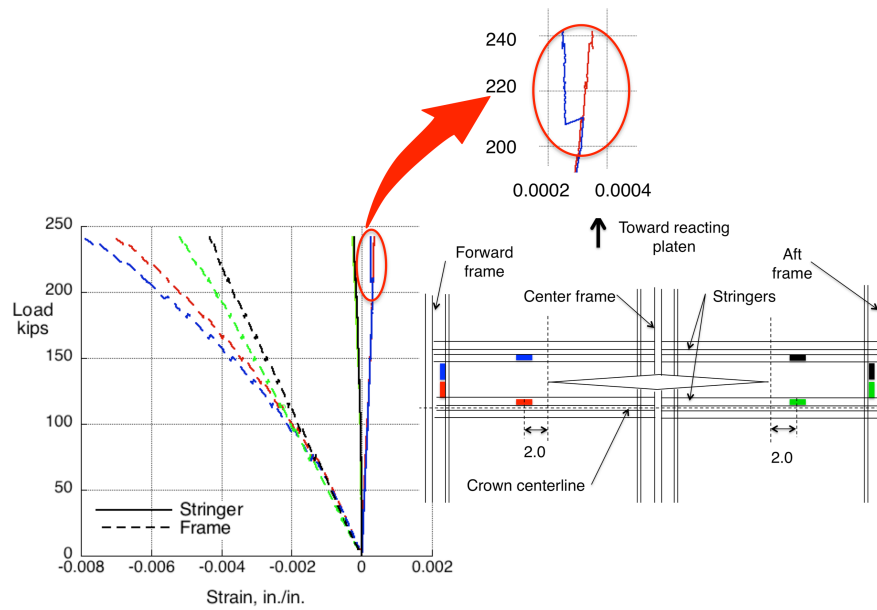
Figure 38. DSD bay flange strains. Sketch not to scale. Dimensions in inches.

Strain gauge results in the damaged bay on the flanges of the surrounding frames and stringers are shown in Fig 38. The strains on the forward stringer flange are positive, indicating that the forward side of the bay deformed outward while strains on the aft stringer flange are negative indicating that the aft side of the bay deformed inward. A discontinuity is seen in the flange of the stringer toward the reacting platen on the forward side of the test article at a load of approximately 208 kips, indicating that a load redistribution took place at this load as damage progressed. Strains on the forward frame flange are more nonlinear than the strains on the aft frame flange, however, both frame flanges are loaded in compression since the outer frames are the primary members supporting the compressive loads in the crown. The flange strain gauges did not fail until the final failure of the test article at approximately 242 kips, or 101% DUL.

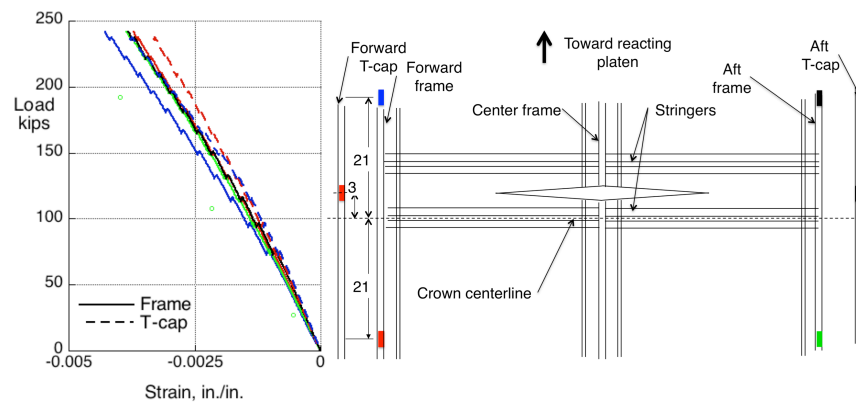
Figure 39. DSD region stiffener and T-cap strains. Sketch not to scale. Dimensions in inches.

Strains further away from the damage on the forward and aft frames and at the T-caps are shown in Fig 39. The strains in the forward and aft T-caps were the same until a load of approx 150 kips, when one forward T-cap displayed an abrupt increase in strain. For load greater than 150 kips, all T-caps continued to support load with no additional abrupt changes in strain behavior. This result indicates that a redistribution of load occurred at this load level. Two strain gauges on each of the forward and aft frames show that the strain in the aft frame 21 inches from the centerline of the MBB in each direction agreed with each other. However, there is some difference

due to the DSD between the forward frame 21 inches from the centerline of the MBB in each direction. However, the forward and aft frames behave in a similar manner.

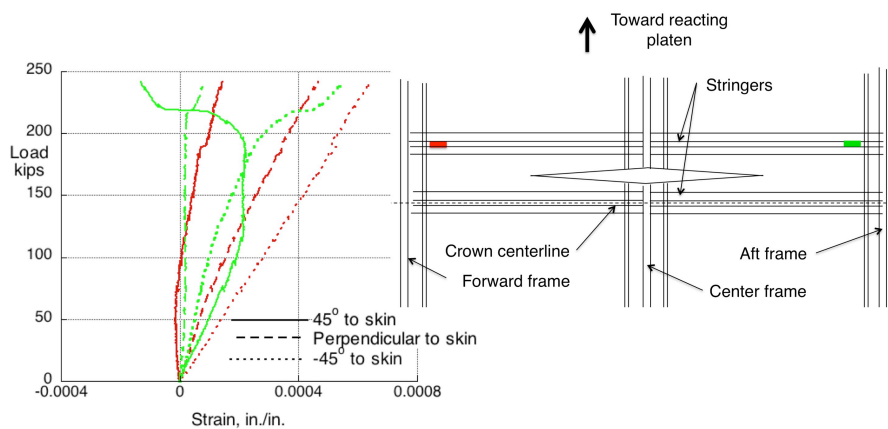
Figure 40. DSD region stringer web strains. Sketch not to scale.

that one leg was perpendicular to the skin and the other two were at $\pm 45^\circ$ to the skin. The strains measured by these rosettes are shown in Fig. 40 and indicate that the stringer near the forward flange recorded an abrupt change in strain at approximately 190 kips, but the results are mostly linear. The rosette at the aft frame, however, displays nonlinear behavior with a significant load redistribution at approximately 218 kips.
